Change of SAR attenuator setting for ScanSAR HV mode

JAXA EORC & ALOS-2 Project Team

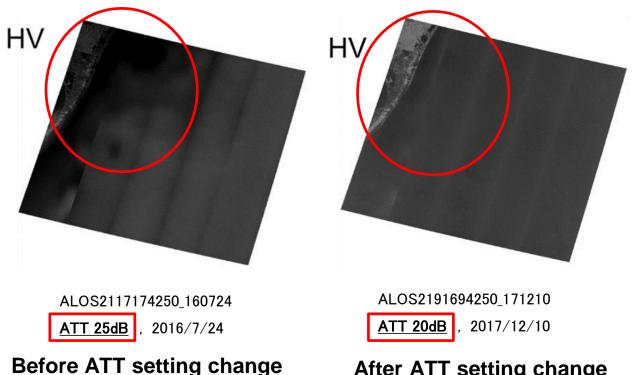
- It was found that the ScanSAR HV-polarization images sometimes became dark and blurred over ocean and coastal regions.
- The cause of this issue was that the onboard ATT (attenuator) setting for ScanSAR crosspolarization was higher.
- On April 11, 2018, the ATT setting for ScanSAR cross-polarization was changed to 20 dB.

Before ATT setting change After ATT setting change ALOS2159754050-ALOS2213574050-180507-WBDR1.5RUD 170508-WBDR1.5RUD ALOS2214403450-ALOS2160583450-180513-WBDR1.5RUD 170514-WBDR1.5RUD
