# Change of SAR attenuator setting for ScanSAR mode

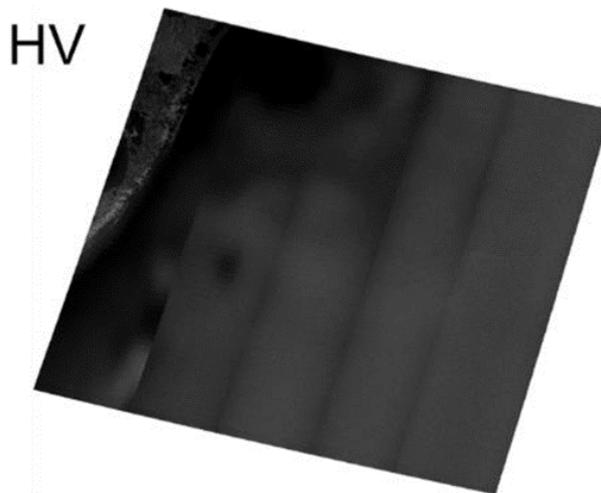
ALOS2117174250\_160724

- It was found that the ScanSAR HV-polarization images sometimes became dark and blurred over ocean and coastal regions.
- The cause of this issue was that the onboard ATT (attenuator) setting for ScanSAR cross-polarization was higher.
- On April 11, 2018, the ATT setting for ScanSAR cross-polarization was changed to 20 dB.

**ATT 25dB**, 2016/7/24

**Before ATT setting change**

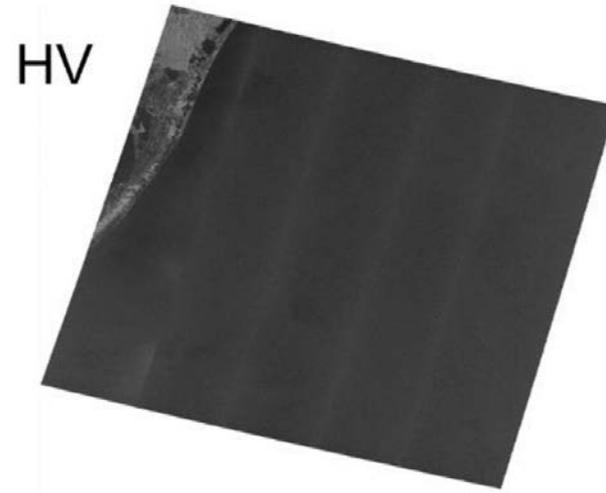
ALOS2191694250\_171210

**ATT 20dB**, 2017/12/10

**After ATT setting change**
