Clutter Routine and 2A25

Jun Awaka

Tokai University, Sapporo Campus

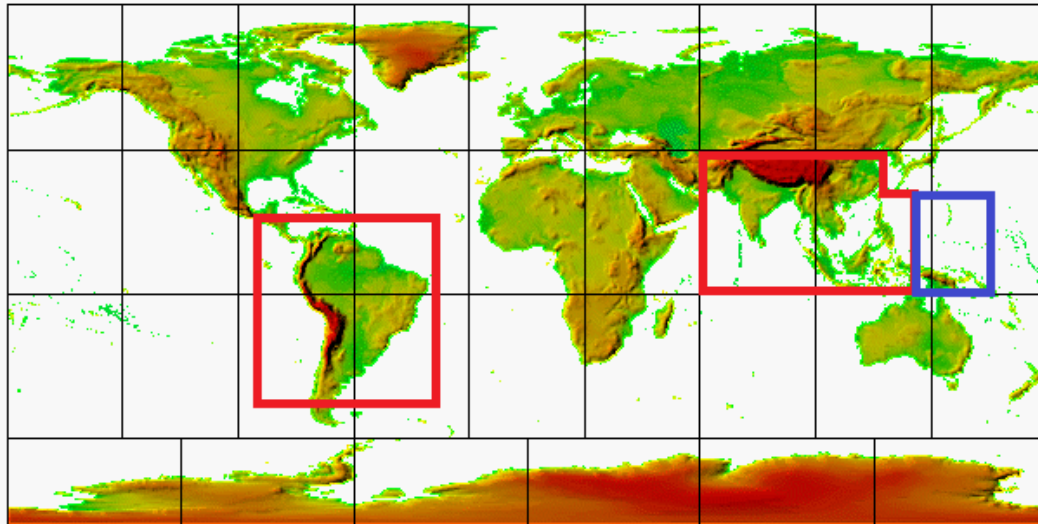
Where DID was replaced with SRTM30 in V7 are marked by bold lines.
 New Guinea area was added to the “final” version to fix a problem.

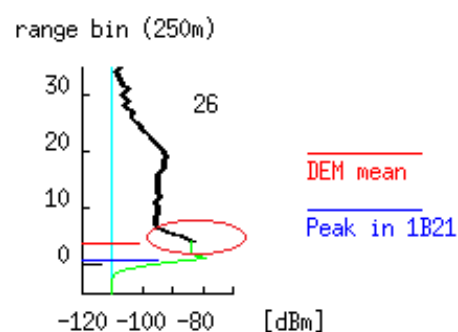
An Example of the problem due to a bug, which was found after the “final” version.
 (A profile of received power in 1B21 ITE229)

orbit 60865, scan 3871, anglebin 26

lat=30.0578, lon=110.6547

nearSurfRain = 173.5 mm/h

e_SurfRain = 164.4 mm/h

This problem occurs over the land where the elevation is lower than 1km.
 The bug was fixed, but the bug-fix code was not handed in.

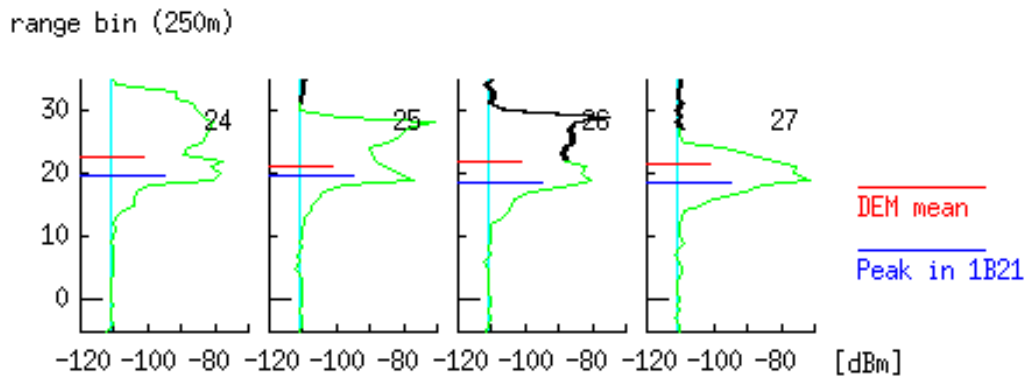
An Example of the problem due to the fact that SRTM30 is not effectively used.

orbit 60869, scan 5552, anglebin 26

lat = 27.5919, lon = 88.1054

nearSurfRain = 300 mm/h

e_SurfRain = 300 mm/h
